Re: Hodgson Road Landslide

PROJECT :	1234-01	NAME:	Hodgson Road Landslide – Structural Remediation Work	
LOCATION:	Williams Lake, BC			
CLIENT:	Pioneer Family Land Partnership	BY:	DS	
DATE:	December, 2015	PAGE:	1	OF 10

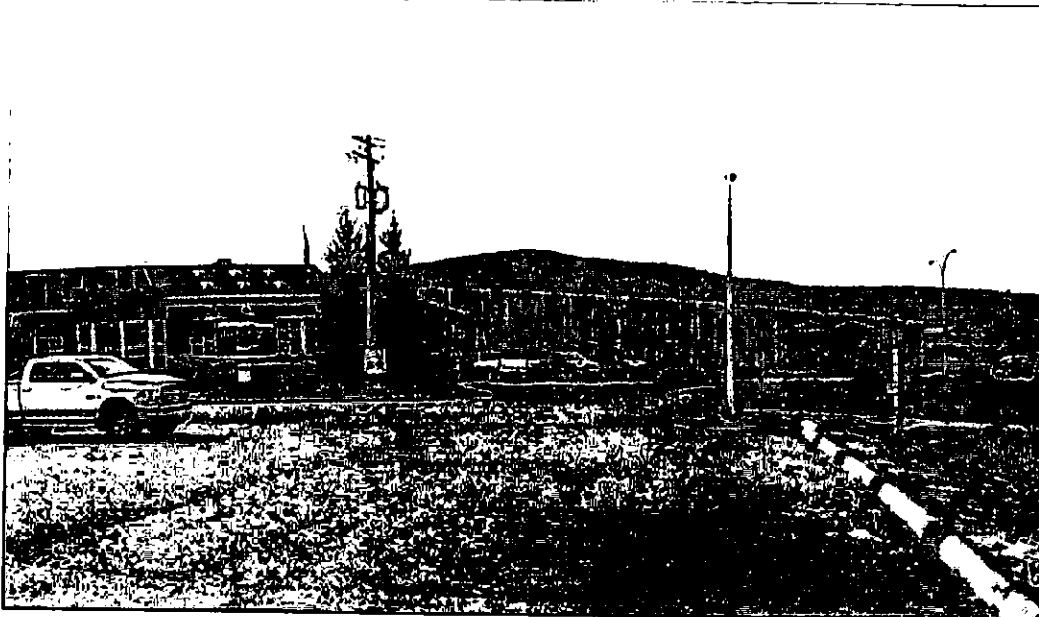
Photo 2: Exterior view looking south before structural remediation work

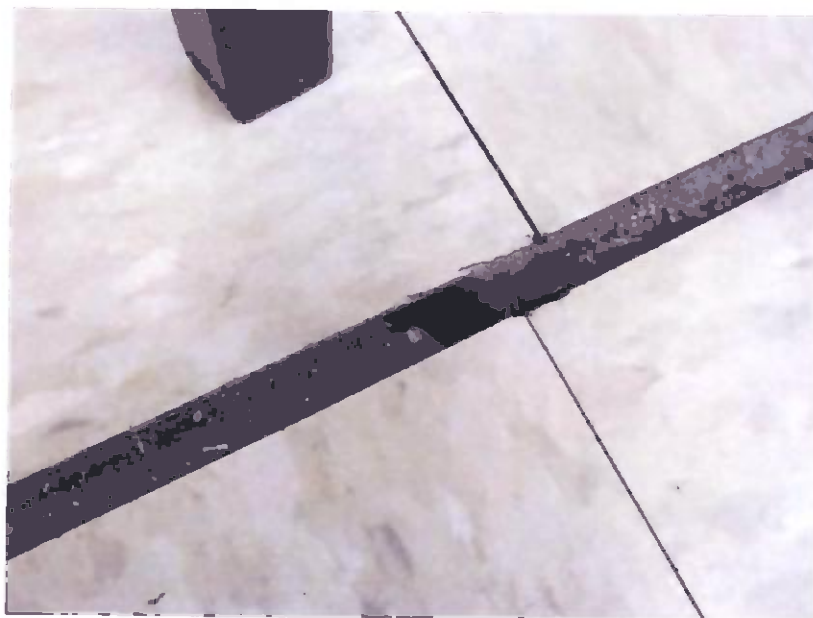
Photo 3: Extensive cracking in cast-in-place slab-on-grade, largely concealed by floor coverings

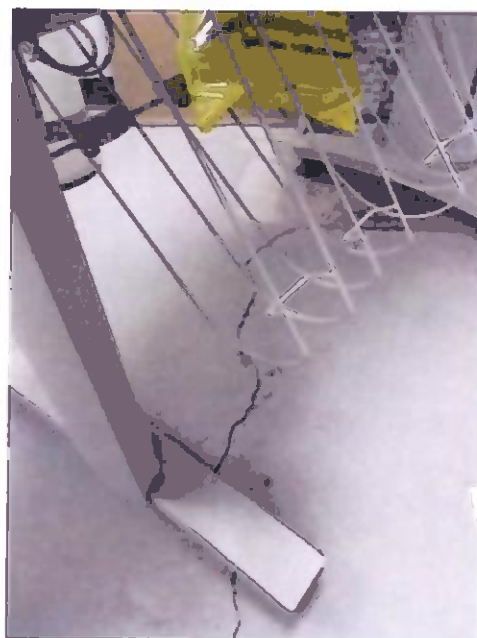
Photo 4: Extensive cracking in cast-in-place slab-on-grade throughout building plan

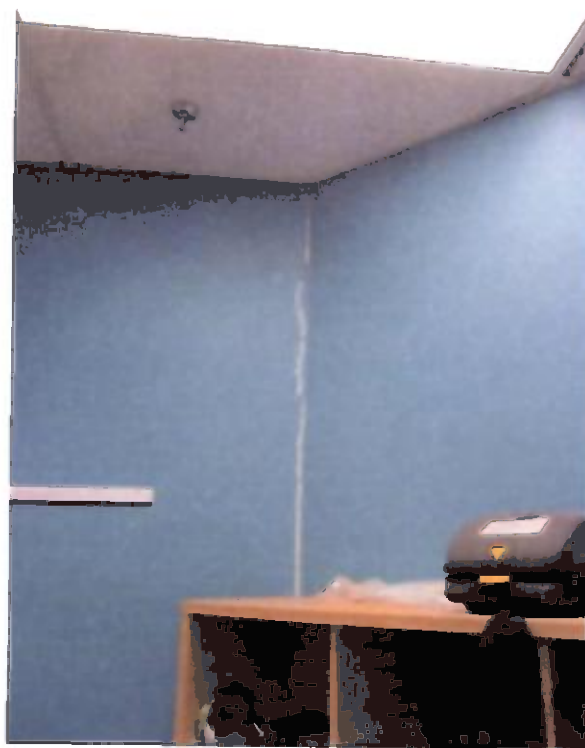
Photo 5: Extensive interior cracking, largely concealed by wall finishes

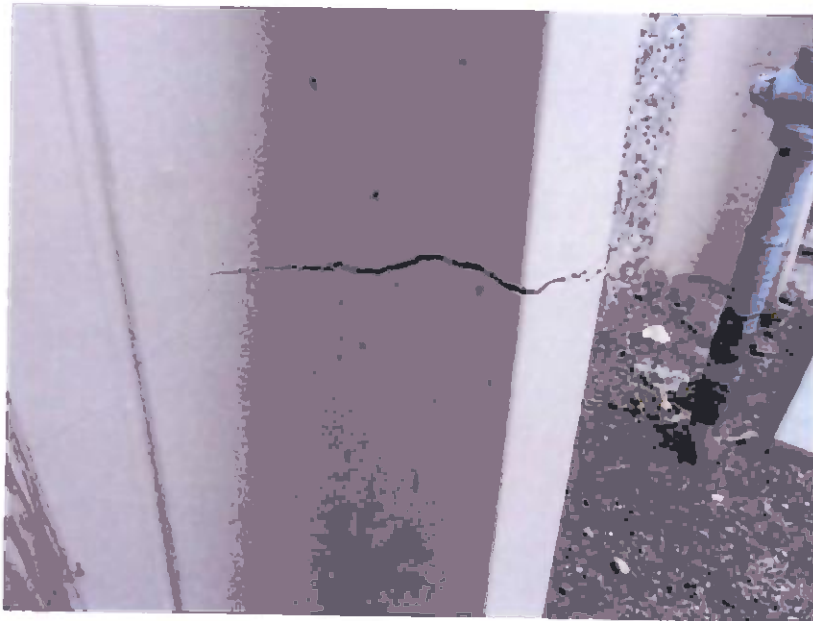
The deformation of the north exterior wall, and a number of other serious structural deficiencies in the facility, has been directly attributed to ground movements associated with the larger instability of the natural slope in the area of Hodgson Road, Dog Creek Road and provincial Highway No. 20. Collectively we refer to that area of instability as the Hodgson Road Landslide.

Photo 9: Extensive displacement and cracking of precast, pre-stressed exterior wall panels

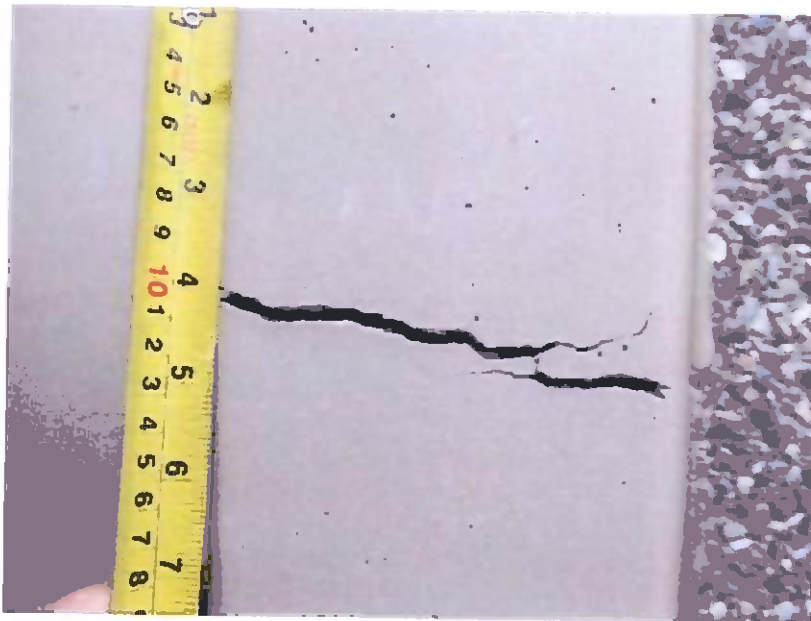
Photo 10: Extensive displacement and cracking of precast, pre-stressed exterior wall panels
