December 22, 2015

Reference No. 1537191-001-L-Rev0

HODGSON ROAD LANDSLIDE

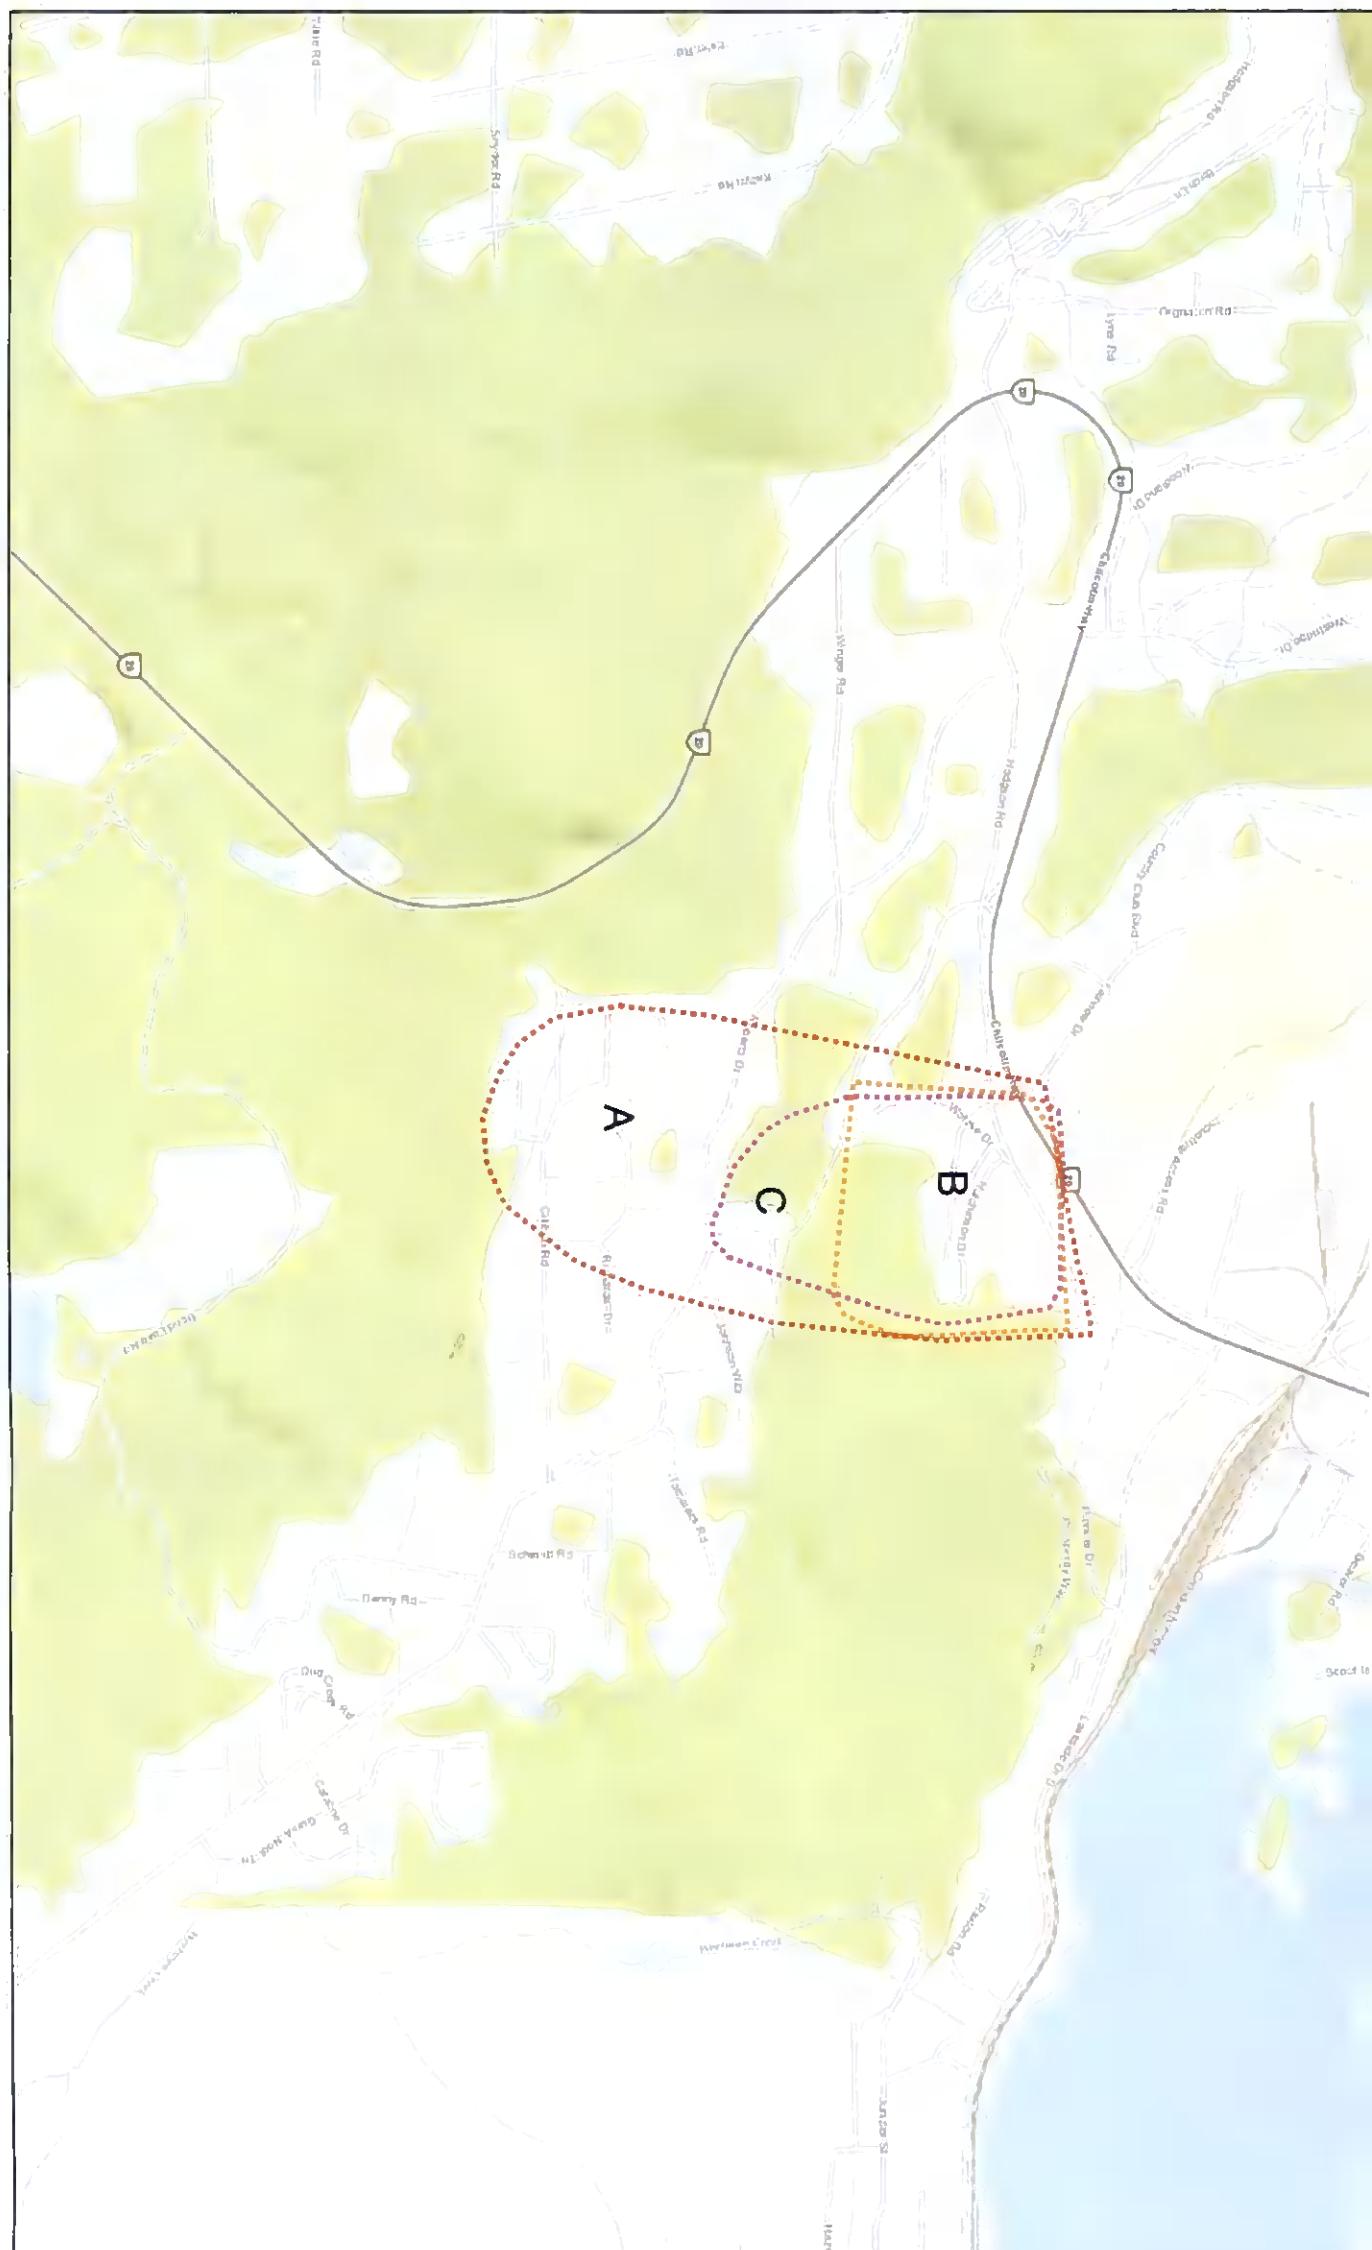
Attachments: Figure 1: Hodgson Road Landslide – Inferred Boundaries

Since 1993, the Hodgson Road Landslide has moved episodically, with total recorded displacements now in the range of 0.3 to 0.4 m. Over the last three years the landslide movements have reportedly become increasingly severe with time. It is understood that the landslide movements are damaging a business centre, a seniors/adult residential complex, a single family house (now abandoned), Highway 20, Dog Creek Road, FortisBC gas lines and City of Williams Lake water mains. The area of ground movement, originally measured at 600m by 600m, has now expanded upslope by a further 300m into the lower part of the Dog Creek Road residential subdivision. The areas of detected movement in 1999 and 2014 are shown in Figure 1, together with the interpreted full outline of this ancient slide mass.

In early 1997, Golder Associates Ltd. was retained by University College of the Cariboo (UCC) to investigate distress in its Campus building on Hodgson Road. Monitoring data collected by the UCC's consultants suggested the distress was caused by deep-seated ground movement, so three deep boreholes were drilled and instrumented to measure ground displacement and groundwater pressure at depth. After a few months of monitoring, Golder determined that there was a deep-seated landslide, with the shear surfaces at the borehole locations some 20 to 30 m below existing grade. From that information and review of stratigraphy and landforms, it was interpreted that the new ground movement was a local reactivation of a large buried ancient landslide with the approximate outline shown in Figure 1.

The area of detected ground movement in 1999 is shown in Figure 1. At that time, all the detected/measured movement was north of Dog Creek Road. The overall ancient landslide may be much larger than the area of detected movement as the toe of a large slide can move faster and sometimes independently of the overall slide mass.

The distress reported near the intersection of Dog Creek Road at Roberts Drive (heave, gas pipe line and distressed house) suggests that the slide area affected by ground movement has retrogressed roughly 300 m upslope, well into the CRD and the lower edge of the upslope rural subdivision.
