The Cariboo Regional District (“CRD”) is providing this letter to you as your property is understood by the CRD to be within or proximate to the Hodgson Road and Dog Creek Road Landslide (“HRL”) zone. We are writing to provide you with a copy of a letter and a memorandum for your information.

Engineers and Geoscientist BC (EGBC)  
Hodgson Road Landslide

16 August 2023

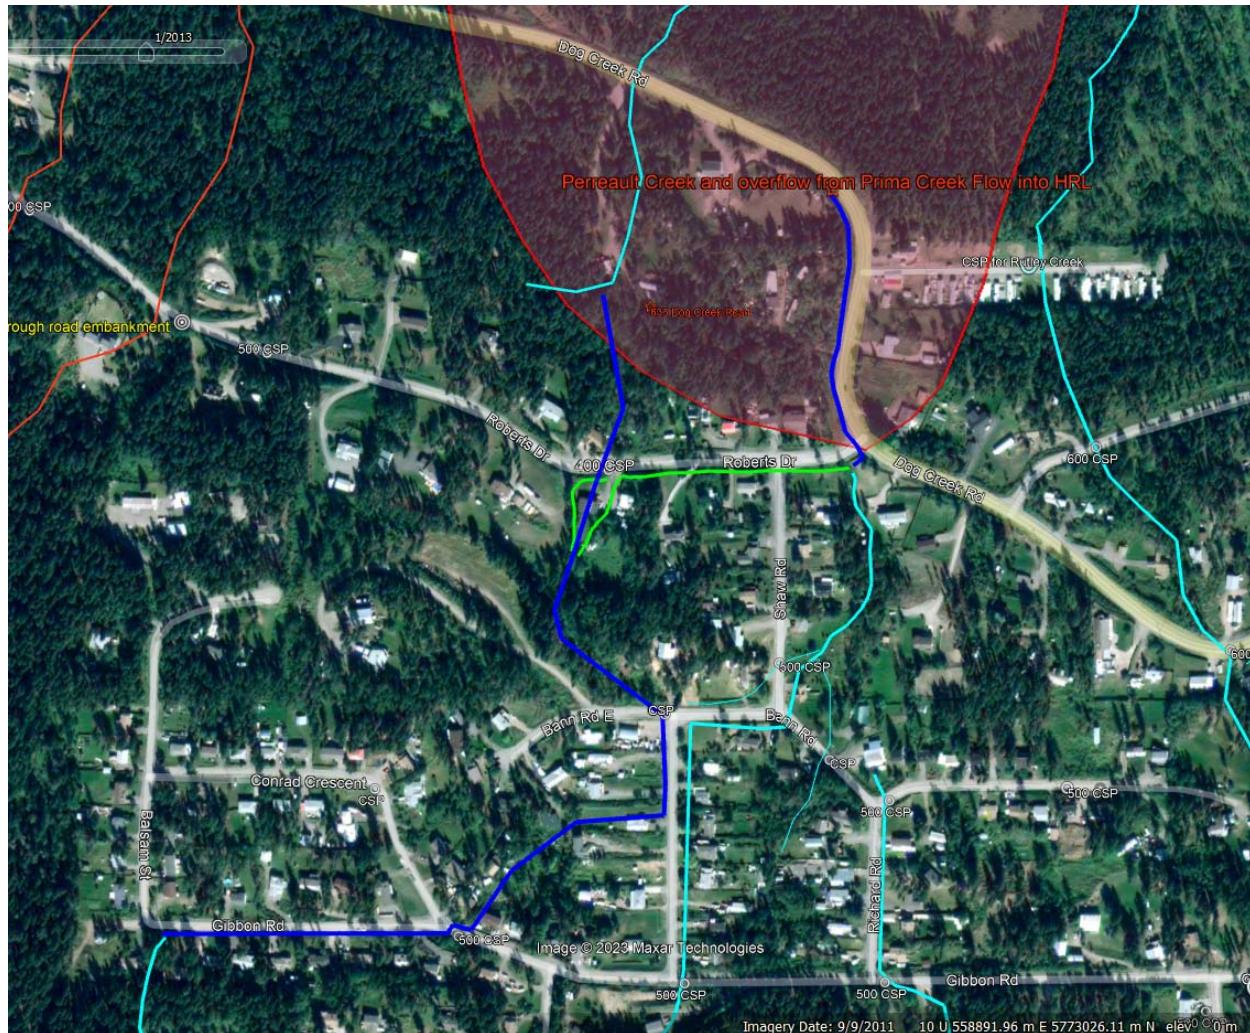
**IMAGE 3 – DRAINAGE WITHIN THE DOG CREEK SUBDIVISION AS RELATED TO THE HODGSON ROAD LANDSLIDE. THE LIGHT BLUE ARE DRAINAGE PATHS, THE DARK BLUE ARE DRAINAGE PATHS CONSIDERED TO BE A SIGNIFICANT ALTERATION. THE LIME GREEN LINES ARE EXAMPLES OF TEMPORARY DIVERSIONS NOTED IN 2020. THE CULVERTS ARE CORRUGATED STEEL PIPE AND ARE ABBREVIATED AS CSP. THE NUMBER IN FRONT OF THE CSP IS THE PIPE DIAMETER IN MM, WHERE KNOWN.**

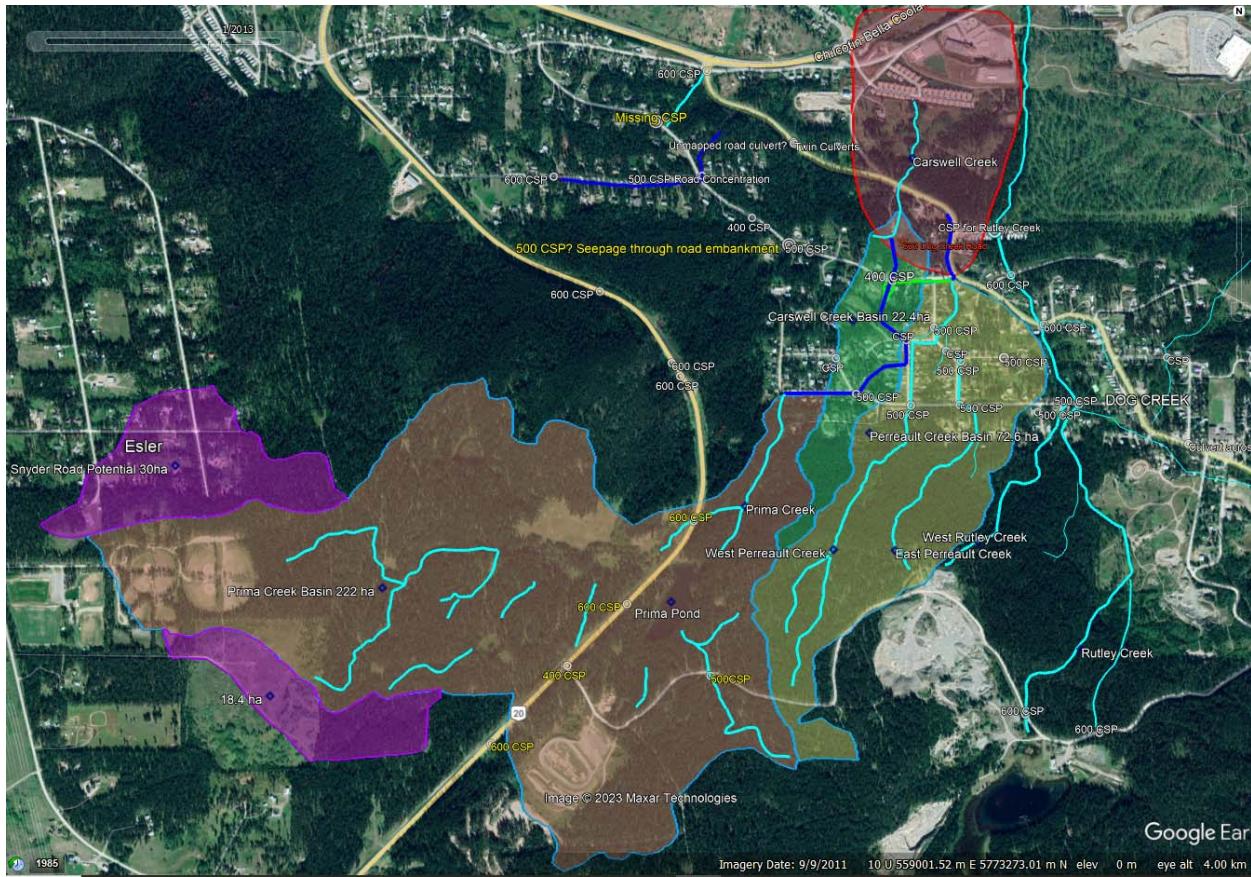
**IMAGE 4 – BASIN AREA CONTRIBUTING SURFACE WATER AND LIKELY SUBSURFACE WATER FLOWS TOWARDS THE HODGSON ROAD LANDSLIDE.**

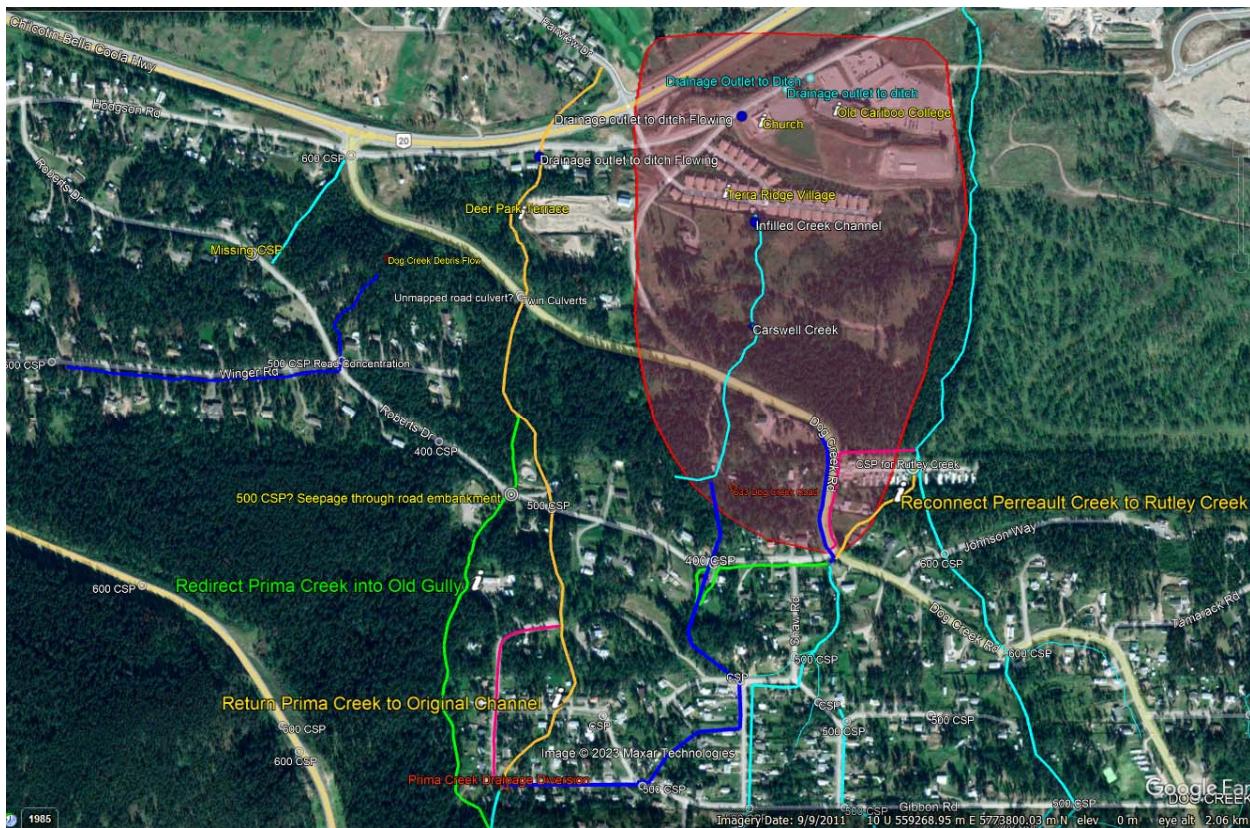
IMAGE 5 – PROPOSED LANDSLIDE MITIGATIVE MEASURES TO ADDRESS DRAINAGE ISSUES WITHIN THE DOG CREEK SUBDIVISION. RETURNING PRIMA CREEK TO THE ORIGINAL CHANNEL WILL REQUIRE THE ADDITION OF CULVERTS ON GIBBON ROAD AND CONRAD CRESENT. REDIRECTING PRIMA CREEK INTO AN OLD GULLY TO THE WEST, WILL REQUIRE THE INSTALLATION, MAINTENANCE, REPLACEMENT OF A CULVERT ON ROBERTS DRIVE. THE RECONNECTION OF PERREAULT CREEK TO RUTLEY CREEK WILL REQUIRE AN ASSESSMENT OF THE EXISTING AND OLD INFRASTRUCTURE TO DETERMINE IF SOME OLD DRAINAGE SYSTEMS EXIST IN THIS AREA WHICH HAD CONNECTED PERREAULT AND RUTLEY CREEKS. WATER FLOW PATHS ALONG WINGER ROAD AND DOWNSLOPE TO ROBERTS DRIVE SHOULD BE ASSESSED SO THAT MITIGATIVE MEASURES CAN BE DEVELOPED TO CORRECT THE DRAINAGE ISSUE AND STABILIZE THE DOG CREEK DEBRIS FLOW. THE POTENTIAL FOR WATER CONCENTRATIONS AND DIVERSIONS UPSLOPE (WEST OF HIGHWAY 20) SHOULD ALSO BE ASSESSED AS PART OF THE DOG CREEK DEBRIS FLOW ASSESSMENT.

Image 5 shows the location for mitigating the drainage issues related to the HRL hazard. The proposed mitigation for the HRL involves both 1 and 2 with 1 having two options. Both 1 and 2 also have the option of utilizing stormwater pipes to return flows to their original paths.

- Option B – Direct Prima Creek into an old gully to the west. This will require the installation, maintenance, replacement of a culvert on Roberts Drive. As the flows would reconnect with the original Prima Creek channel upslope of Dog Creek Road, no additional culverts would be required at Dog Creek Road.

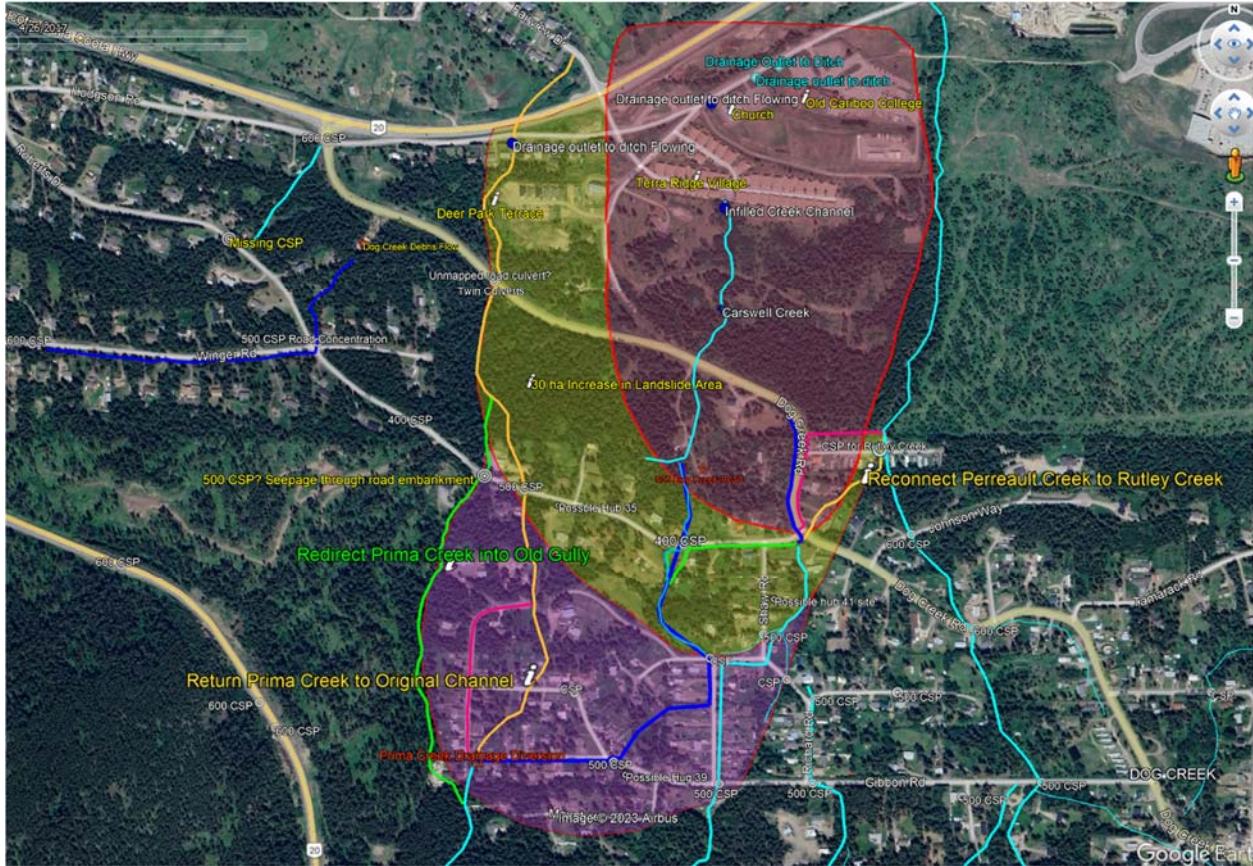
**IMAGE 6 – POTENTIAL EXPANSION OF THE HODGSON ROAD LANDSLIDE WHICH IS LIKELY IF MITIGATION WORKS ILLUSTRATED ON IMAGE 5 ARE NOT UNDERTAKEN.**

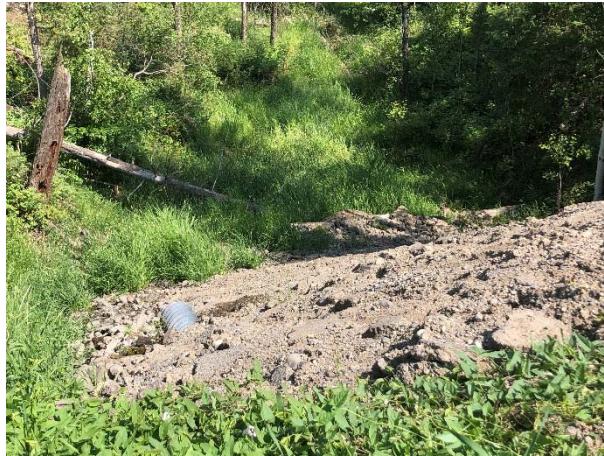
**IMAGE 7 – VIEW LOOKING NORTH DOWN THE RUTLEY CREEK GULLY FROM THE EMBANKMENT FILL CONSTRUCTED ACROSS THE GULLY FOR THE TRAILER PARK. RECENT FILL ON THE SURFACE MAY HAVE BEEN PLACED HERE AS A RESULT OF RECENT ROAD WORKS AT SHAW AND DOG CREEK ROADS.**

trailer park on Dog Creek Road, which infilled a section of Rutley Creek, may have provided a culvert for Perreault Creek as two culverts were observed in the field to be emerging from the embankment fill across Rutley Creek. One of the culverts was flowing and aligned with the Rutley Creek Channel. The second culvert appeared to align more with Shaw and Dog Creek junction. However, this culvert could be for local site drainage. Determining a practicable approach to reconnecting Perreault Creek with Rutley Creek will likely require some cooperation with the owners of the Trailered Park. However, as with Prima Creek, it would be possible to direct Perreault Creek into Rutley Creek using a stormwater piping system. In this situation the water flows could be conducted across the Dog Creek Road at Shaw Road, then down the east side of Dog Creek, past the Trailer Park boundary, then east into the Rutley Creek gully. See Image 7 for a view of the Rutley Creek gully and associated culvert at the trailer park. Reconnecting Perreault Creek to Rutley Creek will require the assessment of the Rutley Creek channel between the Trailer Park and Hodgson Road.

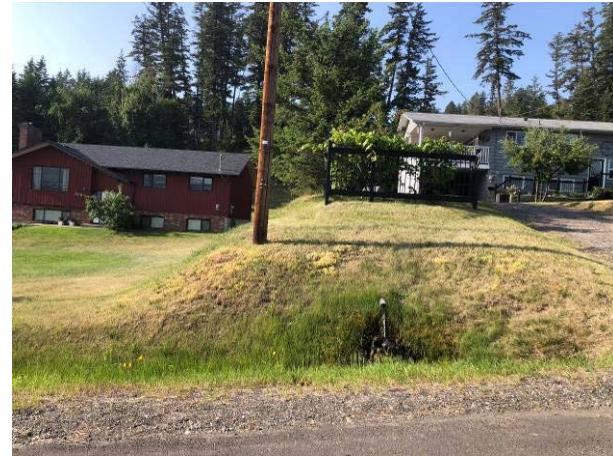
**IMAGE 8 – STEADY WATER FLOWS FROM POND SOUTH OF 419 HODGSON ROAD. POND DOES NOT CONNECT TO LICENSED WATER WORKS. FLOWS IN THE GULLY ARE SUSPECTED TO ALIGN WITH PRIMA CREEK. THERE ARE LICENSED WATER STRUCTURES ASSOCIATED WITH THIS LOCATION WHICH WILL NEED TO BE CONSIDERED WITH THE MITIGATIVE OF DRAINAGE FROM THE DOG CREEK SUBDIVISION AS THIS IS THE PRIMA CREEK CHANNEL.**

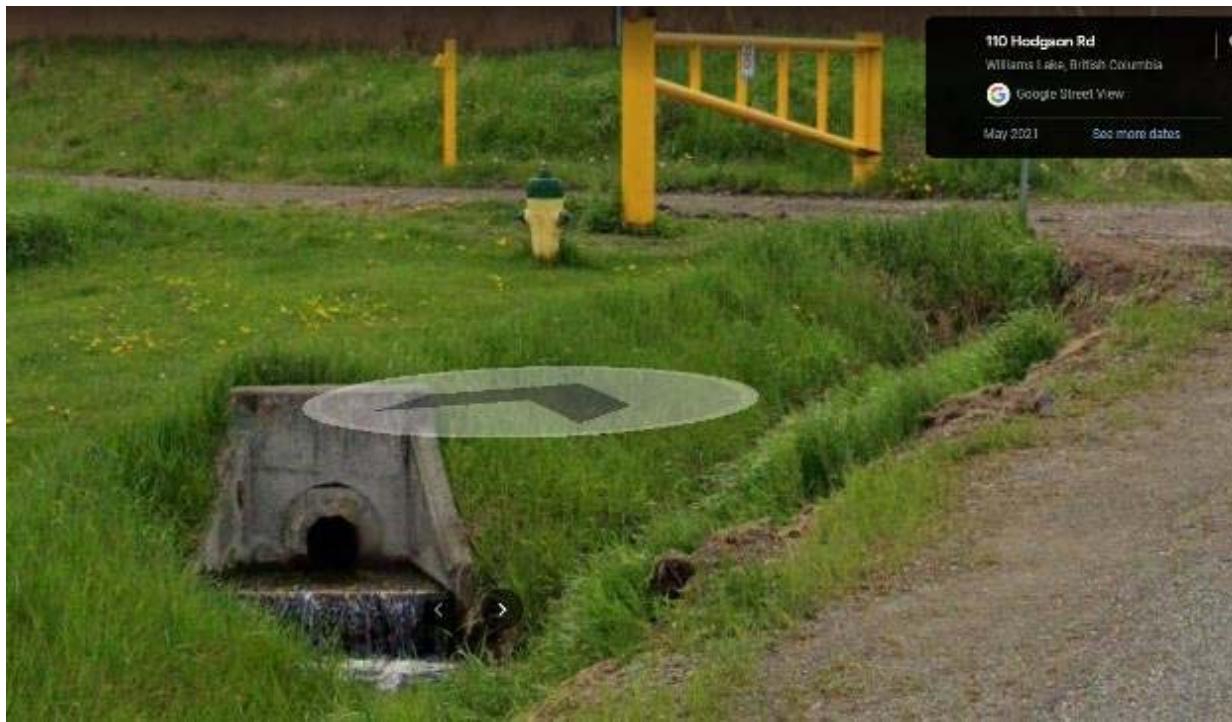
**IMAGE 9 – VOLUME OF WATER FLOW CAPTURED FROM THE COMBINED CARSWELL, PERREAULT, AND PRIMA CREEK BASINS BEING DISCHARGED INTO THE HODGSON ROAD DITCH JUST NORTH OF THE RESERVOIR ACCESS ROAD. THIS DRAINAGE SYSTEM IS UNDERSTOOD TO HAVE BEEN INSTALLED BEHIND A RETAINING WALL CONSTRUCTED FOR THE TERRA RIDGE DEVELOPMENT IN THE EARLY TO MIDDLE OF THE 1990s. IT IS UNDERSTOOD THAT WORK WAS DONE ON THE WALL AND DRAINAGE SYSTEM IN AROUND 2019.**

For the proposed mitigation works noted in 1 above, the design will need to be mindful of the current drainage conditions along Hodgson Road between the South Lakeshore and Dog Creek. Image 8 shows the discharge from the combined, diverted drainage as of May 2021 and Image 9 shows the discharge from the Prima Creek channel location at 419 Hodgson Road. As Prima Creek will be flowing into the channel at 419 Hodgson Road, the channel and associated infrastructure, including consideration of the licensed water works in the area, will need to be considered.

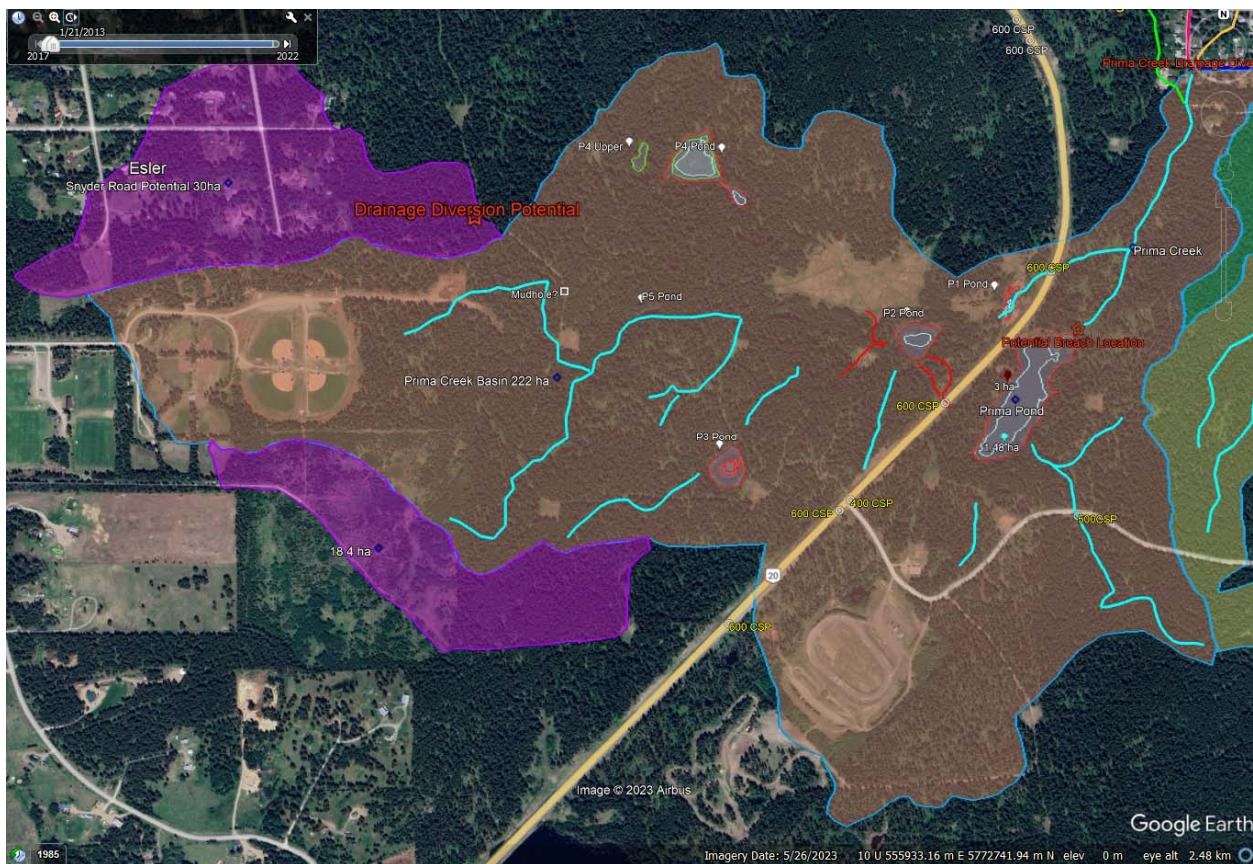
condition of potential breach, which could result in significant damage to downslope residence in the Mountview, Gibbon, Balsam, and Conrad Crescent areas. Such a breach could potentially lead to injury and loss of life. Image 10 provides additional details regarding the Prima Pond area.

IMAGE 10 – DETAILS REGARDING THE PRIMA CREEK BASIN AND THE EXPANSION OF PONDS SINCE THE MIDDLE OF THE 1990s

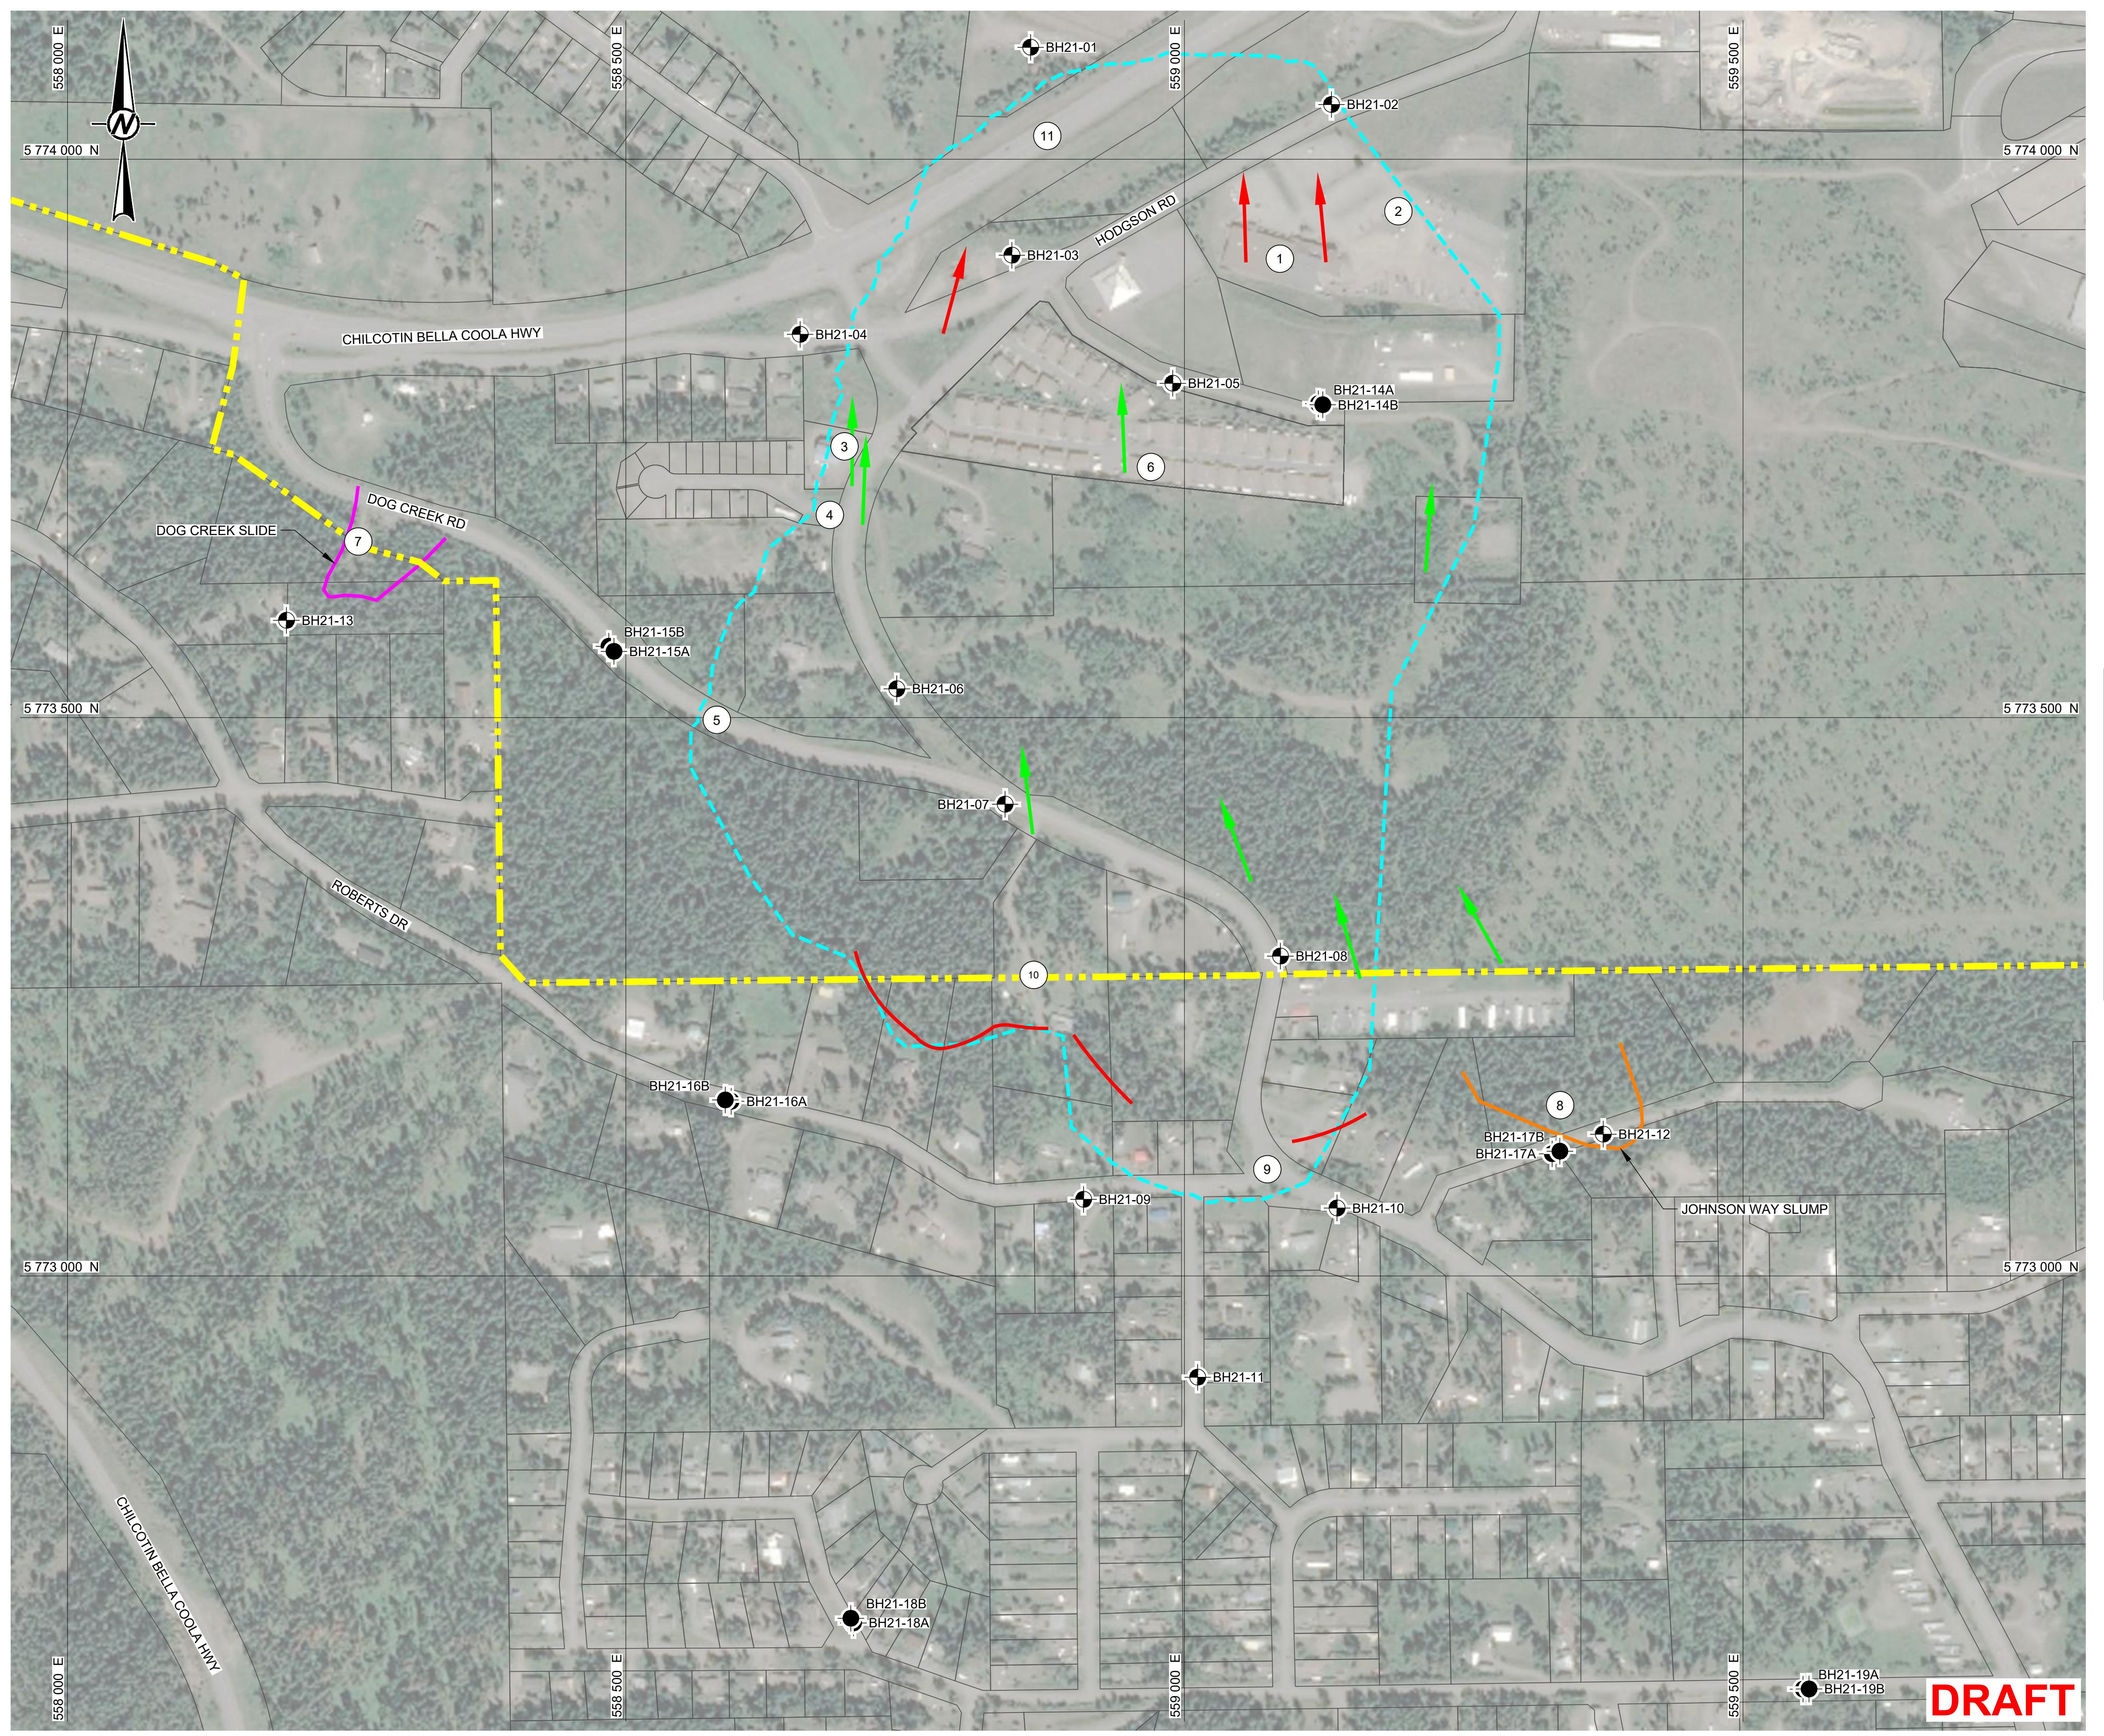
**Ground Movement Indicators: Extract from Geotechnical  
and Hydrogeological Subsurface Investigation Report  
Issued by Golder Associates Ltd., Rev B (Sep 2022)**

- Notation #5 signifies the noticeable bump in the roadway observed prior to the recent milling and resurfacing work carried out by the City of Williams Lake.
- Notation #11 refers to the ongoing milling and resurfacing work on the Chilcotin Bella Coola highway (Hwy 20), which is a direct consequence of the landslide's movement.

- Notation #9 illustrates the damage sustained by the Fortis gas main, located at the intersection of Dog Creek Road and Shaw Road.
- Although not indicated in this figure, recent incidents of water-main breaks have been reported in close proximity to or around the slide boundaries. These events have been covered in the news, with additional information available in the following links:
  - <https://www.wltribune.com/news/hodgson-road-land-slippage-likely-cause-of-latest-williams-lake-water-main-break-city/>
  - <https://www.wltribune.com/news/two-williams-lake-water-main-breaks-slated-for-permanent-repairs/>

- Notation#1: Pioneer complex damage and heave.
- Notation #3: Damage to the house at 505 Wotzike Drive.
- Notation #4: Bump in the driveway of the house at 505 Wotzike Drive.
- Notation #6: Ongoing damage to the Terra Ridge Senior complex.
- Notation#10: Cracking and damage to the house at 633 Dog Creek Road.
- While not noted on the plan, there are unconfirmed reports of damage or historical damage to other structures, typically on the perimeter of the slide.

SURFICIAL	GENERAL DESCRIPTOR
1	1990S-CURRENT: BUILDING DAMAGE AND HEAVE
2	1990S: SLOPE INCLINOMETERS IDENTIFYING MOVEMENT AT APPROXIMATELY 20 AND 30 M DEPTH
3	PRE-2014: HOUSE DAMAGE
4	2020 - CURRENT: BUMP IN DRIVEWAY
5	2021: BUMP IN ROAD
6	ONGOING: DAMAGE
7	ONGOING: DOG CREEK SLIDE
8	ONGOING: JOHNSON WAY SLUMP
9	2014: DAMAGE TO FORTIS GAS MAIN
10	2020-CURRENT: CRACKING AND DAMAGE TO HOUSE AT 633 DOG CREEK ROAD
11	ONGOING - CHILCOTIN BELLA COOLA HIGHWAY MILLING AND RESURFACING ANNUALLY
