# BC Register of Historic Places: PDF Data Entry Template

## COMMON NAME

150 Mile Barns

## Heritage Assessment for Lot 1, D.L.12, at 150 Mile House, B.C.

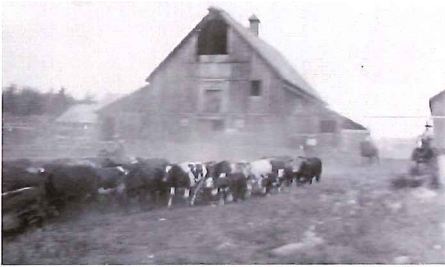
150 Mile Barn, 1933. Museum of Cariboo-Chilcotin.

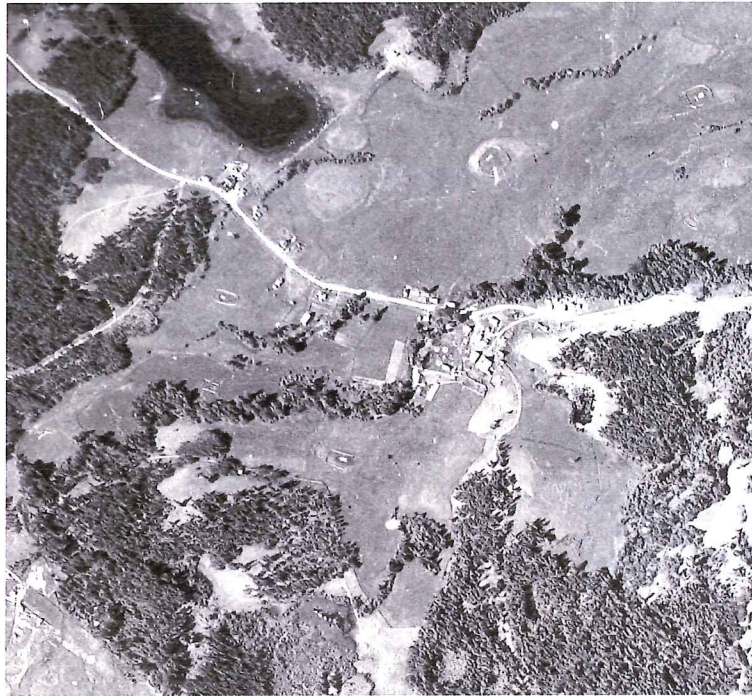
Aerial view of site and context, 1948.

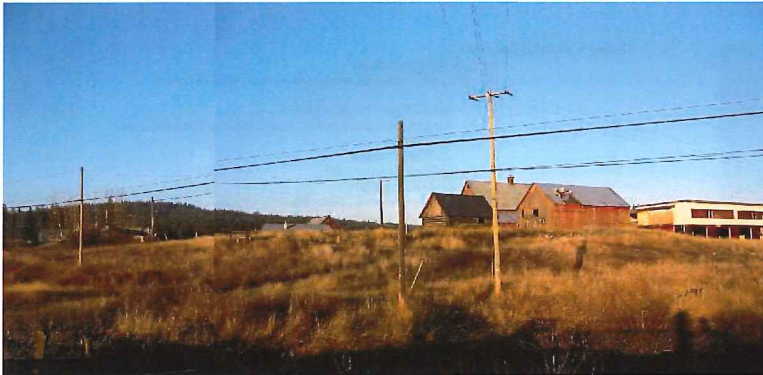
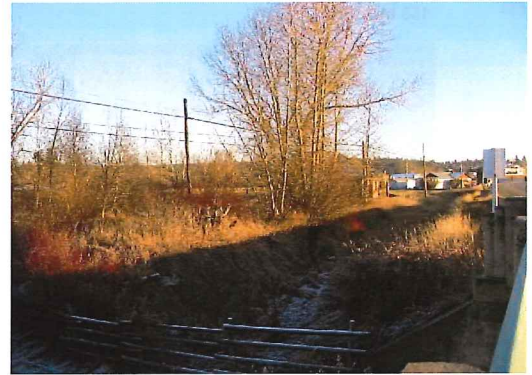
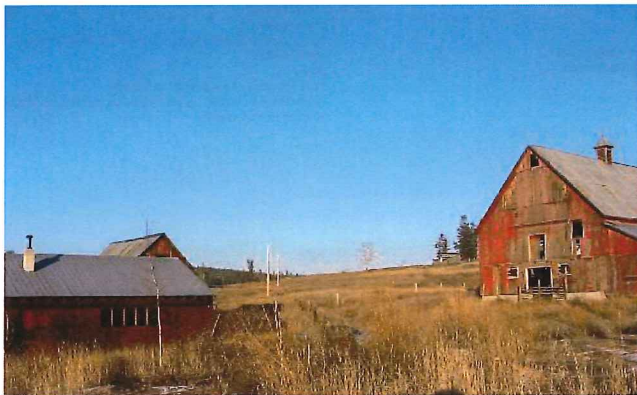
**Stable**  
150 Mile House, B.C.

- rot at historical ground line
  - barn red colour
- hay-storing infrastructure
  - large vertically-opening door to hayloft (decommissioned)
  - traveling hoist on track at peak of hayloft

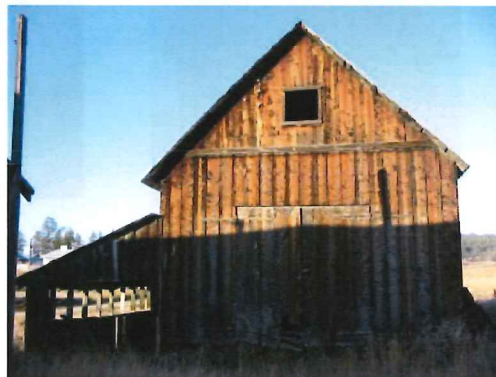
**Blacksmith's Shop**  
150 Mile House, B.C.

- siting by Cariboo Highway
- siting apart from main Stable and Barn buildings, but related orthogonally to those buildings
- roof
  - simple main roof gable form
  - flanking shed extension
  - galvanized metal roofing
- overall dimension and grid
- framing and foundation
  - lumber framing
  - foundation including timber beams supported on boulder foundations
- cladding
  - substantial vertical board siding
  - unpainted wood
- fenestration including boarded-up window openings
- miscellaneous interior details and pieces, which can give clues to past usage

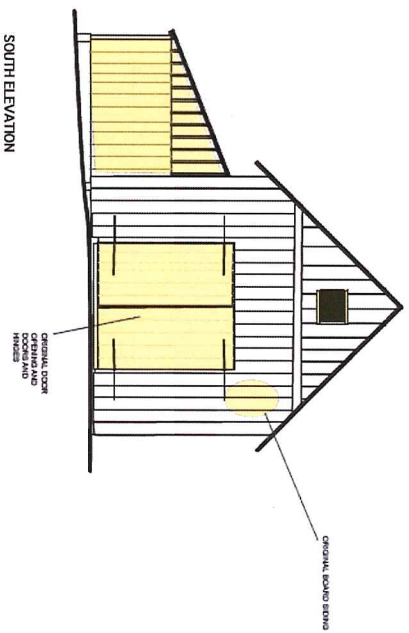
SOUTH ELEVATION

DAMAGED METAL ROOFING

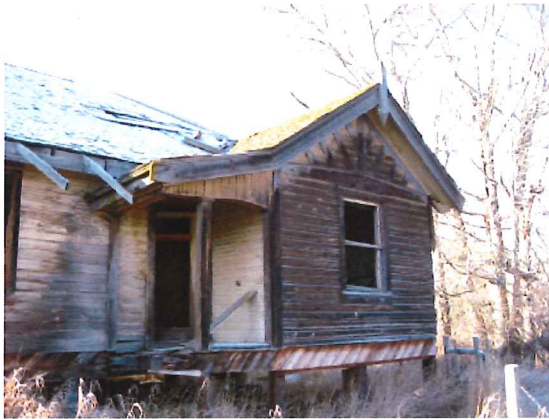
**150 Mile House Lockup**  
**150 Mile House, B.C.**

- roof
  - simple main roof gable form
  - original wood (likely fir) shingles
  - shallow slope of compound-sloped roof over porch
- form
  - bungalow style
- cladding
  - drop-siding
  - decorative trim in gable ends
  - bargeboard with decorative finial at peak
  - double-hung windows
- miscellaneous details
  - signs of original heating systems and fireplaces
  - porch detailing

THE 150 MILE HOUSE LOCK-UP BUILDING IS GENERALLY IN VERY PRECARIOUS CONDITION:

- NOT SITUATED ON A PERMANENT SOUND FOUNDATION
- NOT ORIENTED NECESSARILY IN ITS ORIGINAL ORIENTATION
- NOT NECESSARILY IN THE BEST LOCATION FOR ADAPTIVE RE-USE
- RARE ORIGINAL FIR SHINGLE ROOF IN DETERIORATED CONDITION
- DOORS AND WINDOWS IN VERY POOR CONDITION, OR NON-EXISTENT
- ORIGINAL EXTERIOR SIDING AND TRIM HAS LOST MOST OF ITS PROTECTIVE PAINT COATING, SPEEDING DETERIORATION OF THE WOOD FIBER
- INTERIOR FINISHES ARE THREATENED BY EXPOSURE TO WEATHER.

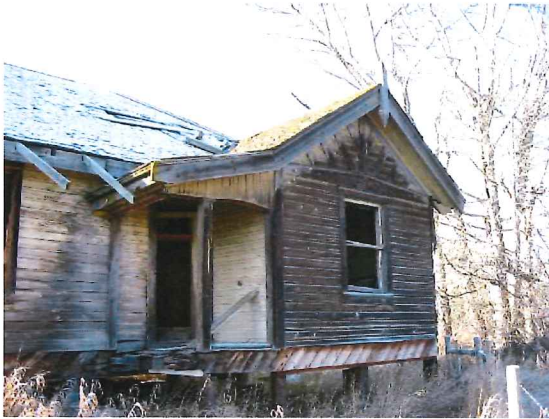
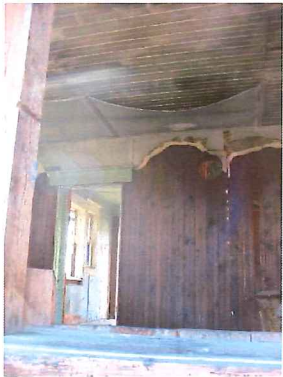
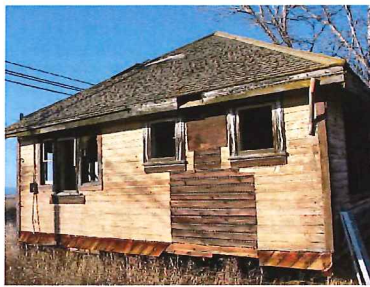
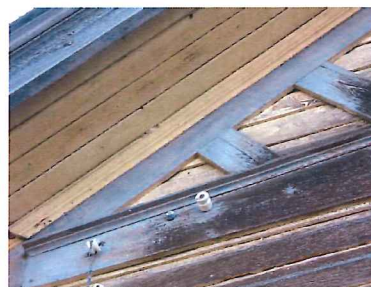
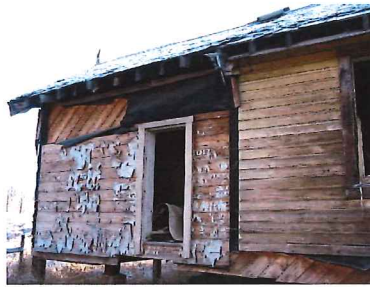
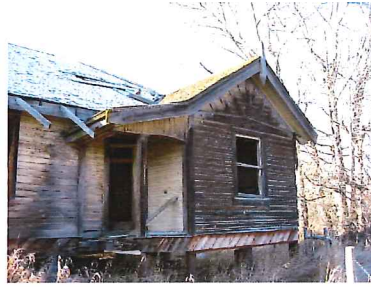
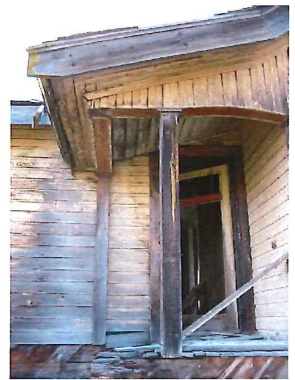
NOTE:  
VIRTUALLY ALL PHYSICAL ASPECTS OF THE EXISTING REMAINS  
OF THIS BUILDING ARE DETERIORATING DUE TO LACK OF  
PROTECTION FROM THE WEATHER
