# **Geotechnical Assessment:**

## **Anahim Lake Airport Apron Expansion**

**Prepared for:**  
**HM Aero Aviation Consulting**

**Project Manager: Hans Jorgensen, P. Eng.**  
**Project Number: 26-H-041**

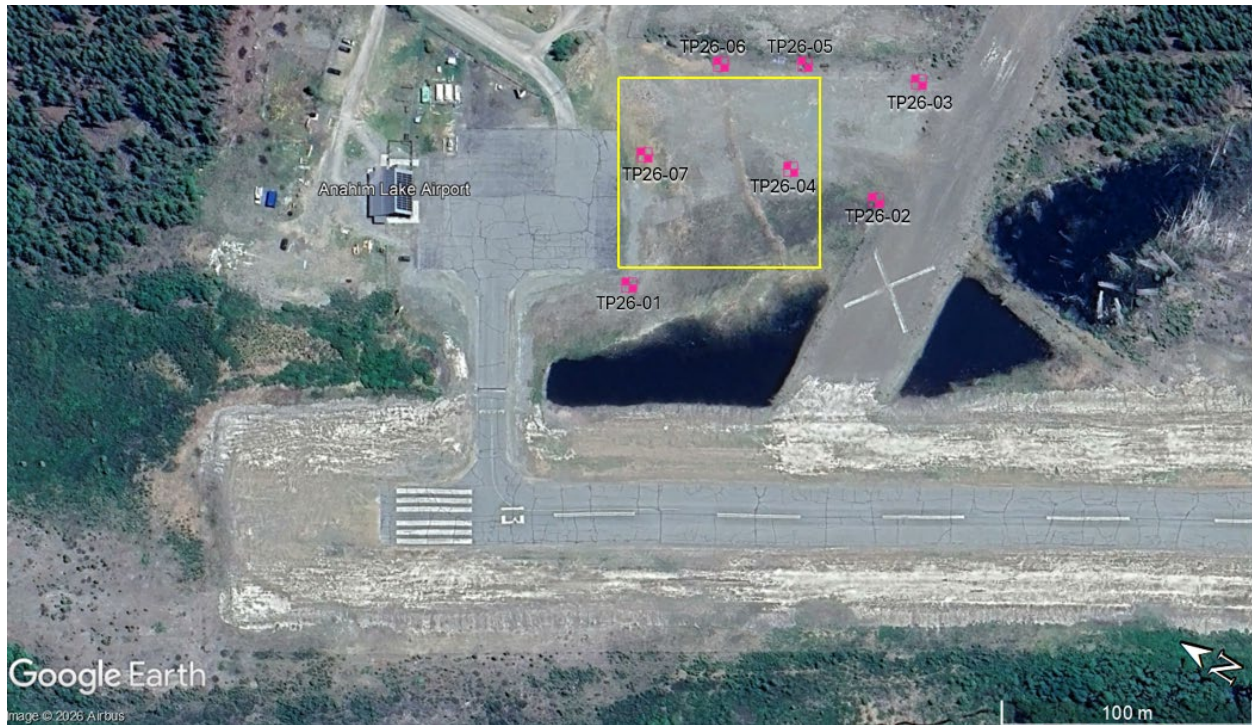
Figure 1. The subject property and investigation locations (Google Earth Imagery)

We carried out a test pit investigation on the subject property on June 4, 2026. Subsurface conditions were reviewed in seven test pits, TP26-01 to TP25-07, at the locations shown in Figure 1. The test pits were excavated with a Hitachi 210 excavator (John Williams Contracting Ltd.) under the direction of our field personnel. As the test pits were advanced, we observed and recorded subsurface conditions encountered at each location. At select depths we performed field soil tests and collected soil samples from the excavated soil. The samples were submitted to our laboratory for soil index tests. Following our review and sample collection the test pits were backfilled with the excavated soil.
