The Cariboo Regional District (“CRD”) is providing this letter to you as your property is understood by the CRD to be within or proximate to the Hodgson Road and Dog Creek Road Landslide (“HRL”) zone. We are writing to provide you with a copy of a letter and a memorandum for your information.

Engineers and Geoscientist BC (EGBC)  
Hodgson Road Landslide

16 August 2023

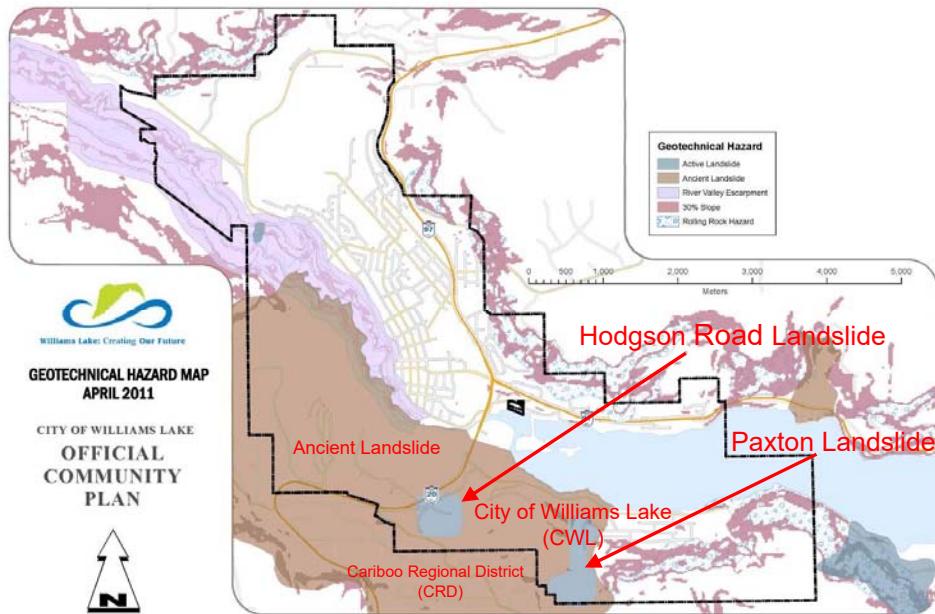
The Hodgson Road Landslide (HRL) was first detected in about 1993. The original movement was confined to within the City of Williams Lake (CWL) and impacted roads, utilities, and buildings as well as Highway 20 (the jurisdiction of MOTI). Image 1 shows the location and initial extent of the HRL with respect to the responsible land jurisdictions. The initial landslide was in the order of 35 to 40ha and is situated mostly on gentle slopes. Between 1997 and 1999 the landslide was investigated by Golder Associated Ltd (GAL), and recommendations were made to dewater the landslide by installing pumped wells and / or horizontal drains.<sup>1</sup> It is my understanding that no stabilization measures have been undertaken to date.

IMAGE 1 – CITY OF WILLIAMS LAKE GEOTECHNICAL HAZARD MAP (DOWNLOADED FROM THE CITY'S WEBSITE ON 6 JUNE 2023). ANNOTATIONS (IN RED) ADDED FOR REFERENCE PURPOSES.

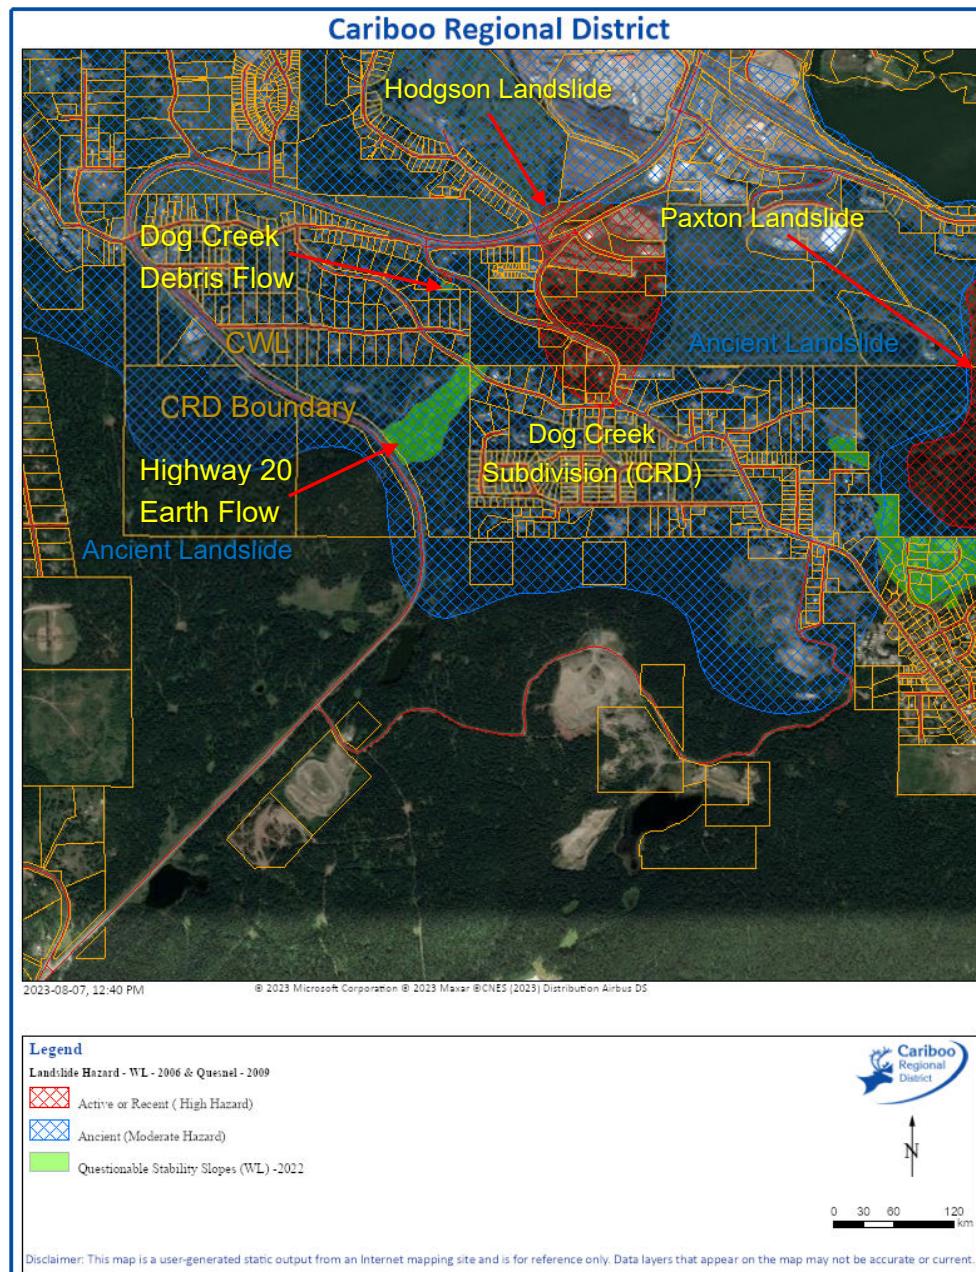
The HRL expanded upslope (southward) in about 2015, crossing Dog Creek Road and entering the Cariboo Regional District (CRD) jurisdiction. The expanded landslide is about 48ha in size and involves an estimated 14 million cubic metres of material. As a result of this expansion out of the CWL and into the CRD, the landslide impacted more roads managed by MOTI as regional district roads are the responsibility of MOTI. The approximate boundaries of the expanded HRL are shown on Image 2. This

**IMAGE 2 – CARIBOO REGIONAL DISTRICT GEOTECHNICAL HAZARD MAP DOWNLOADED 7 AUGUST 2023. KEY FEATURE ANNOTATIONS ADDED FOR DISCUSSION PURPOSES.**
